| • | Report ID: | 27,176,276 | Version: | 1 |

| Make: | Mazda | Model: | CX-5 |
| Body Style: | Wagon | Year: | 2015 |

| Road Conditions During Test Drive | | Dry |
|---|---|---|
| Inspected by: | Gary Adams | |

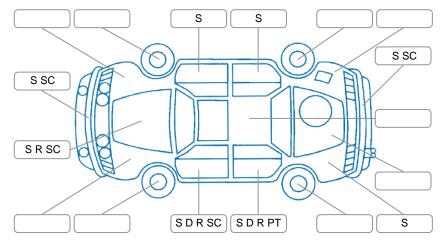
* = DecalsS = ScratchW = Significant scuffs R = RustC = CrackD = DentPT = Paint defect P = Pin dentSC = Stone Chips

Note: some defects and blemishes may not be displayed in the diagram $\,$

Tire inflation device in the boot. Stone chips and scratches all over
