Basic Condition Guide

•	Report ID:	27,177,481	Version:	2
	Created:	17 Nov 2025

Make:	Nissan	Model:	Dualis
Body Style:	Wagon	Year:	2007
Rego No.:	LCQ743	Rego Expiry:	28 Mar 2026
WoF Expiry:	28 Nov 2025	Odometer:	225,765 Kms
Good No.:	27177481	VIN:	7AT0DH7HX17072697
Next Service:	225,769KMs	Service History:	No
diagnostic testing ur	only. Consideration is mad	een driven up to 50km/l	arts have not been dismantled or n from cold. The Vendor recommends a or an additional charge.

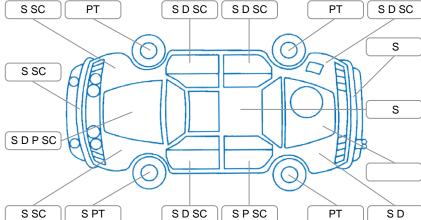
Note: some defects and blemishes may not be displayed in the diagram $\,$

Paint defect on side mirrors. Drivers door lock moulding missing. Tyre iron missing.

Stonechip in windscreen.

Aerial missing.
