# **Basic Condition Guide**

Make:	Holden	Model:	Commodore			
Body Style:	Sedan	Year:	2009			
Rego No.:	FZK361	Rego Expiry:	04 Nov 2025			
WoF Expiry:	04 Jul 2026	Odometer:	300,000 Kms			
Good No.:	27182588	VIN:	6G1EP5EY3AL404743			
Next Service:	308,464kms	Service History:	No			
Note: This report is not a warranty  This report is a guide only. Consideration is made for age and mileage. Parts have not been dismantled or diagnostic testing undertaken. The vehicle has been driven up to 50km/h from cold. The Vendor recommends a full mechanical inspection prior to purchase and this can be arranged for an additional charge.

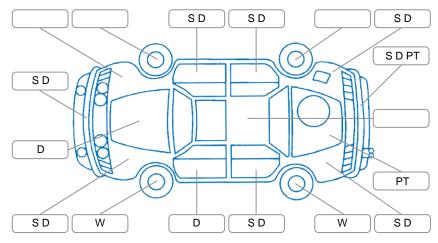
W = Significant scuffs S = ScratchR = RustC = Crack\* = DecalsD = DentPT = Paint defect P = Pin dentSC = Stone Chips

Note: some defects and blemishes may not be displayed in the diagram
