| Report ID: | 27,564,358 | Version: | 1 |

| Make: | Mercedes-Benz | Model: | A250 |
| Body Style: | Hatchback | Year: | 2013 |

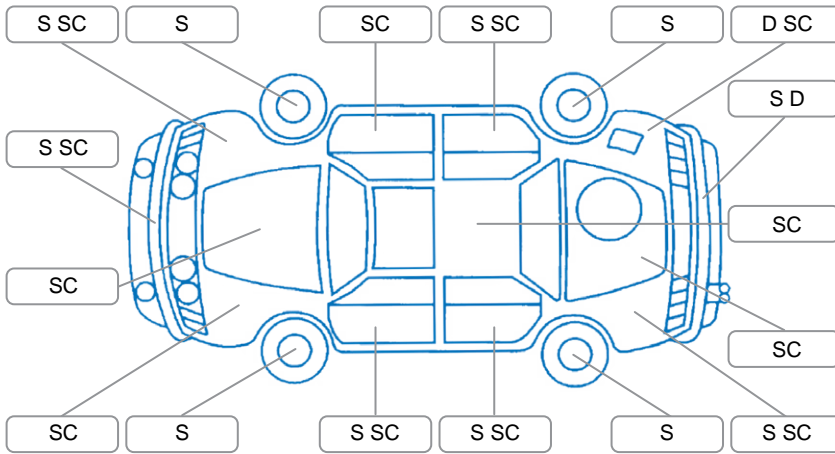
**Key**  
 S = Scratch    R = Rust    C = Crack    \* = Decals    W = Significant scuffs  
 D = Dent    PT = Paint defect    P = Pin dent    SC = Stone Chips

Note: some defects and blemishes may not be displayed in the diagram

Stone chips in windscreen.
