# **Basic Condition Guide**

•	Report ID:	27,786,990	Version:	2
	Created:	13 Nov 2025

Make:	Mazda	Model:	Atenza
Body Style:	Sedan	Year:	2004
Rego No.:	FKS391	Rego Expiry:	21 Feb 2026
WoF Expiry:	25 Jul 2026	Odometer:	284,759 Kms
Good No.:	27786990	VIN:	7AT0C139X10113238
Next Service:		Service History:	No

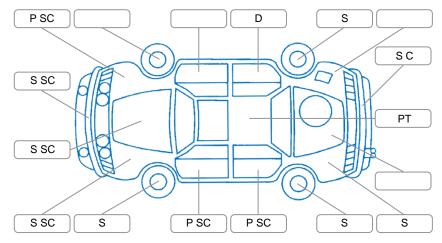
Note: some defects and blemishes may not be displayed in the diagram  $\,$

Right front wing mirror broken Spare wheel missing
