Basic Condition Guide

| Make: | Mitsubishi | Model: | Lancer |
| Body Style: | Sedan | Year: | 1996 |

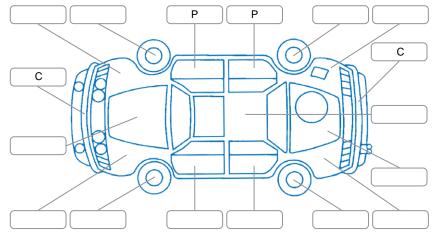
| , | | | | |
|---|---|---|---|---|
| S = Scratch | R = Rust | C = Crack | * = Decals | W = Significant scuffs |
| D = Dent | PT = Paint defect | P = Pin dent | SC = Stone Chips | |

Note: some defects and blemishes may not be displayed in the diagram

Body Inspection Comments

Right fog light is cracked. Wiper Scratches on windshield. Front and rear lip spoilers are cracked. LVV cert for adjustable suspension. After market muffler & air in take. No wheel centre caps. Bonnet grill is missing rain guard.
