Basic Condition Guide

Report ID:	27,791,991	Version:	2
Created:	26 Nov 2025

Make:	Toyota	Model:	Hiace		
Body Style:	Van	Year:	2016		
Rego No.:	JQA844	Rego Expiry:	28 Feb 2026		
WoF Expiry:	16 Feb 2026	Odometer:	186,826 Kms		
Good No.:	27791991	VIN:	JTFPT22P200016848		
Next Service:	190,000km	Service History:	No		
Note: This report is not a warranty This report is a guide only. Consideration is made for age and mileage. Parts have not been dismantled or

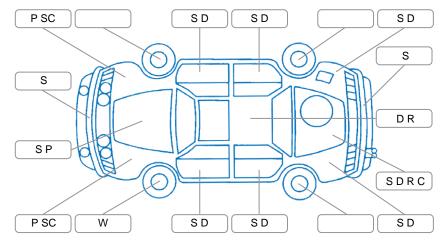
rey				
S = Scratch	R = Rust	C = Crack	* = Decals	W = Significant scuffs
D = Dent	PT = Paint defect	P = Pin dent	SC = Stone Chips

Note: some defects and blemishes may not be displayed in the diagram

High stop light cracked. R bumper cracked. Tools missing. Mobility ramp installed. RF Seat base pad torn. F bumper left trim missing. RF&LF door mirrors gouged. LR wheel centre cap and trim missing. LF tyre sidewall cracking. L sill dented. Bootlid large dents. Rusty roof.
