## **Basic Condition Guide**

•	Report ID:	27,792,922	Version:	1
	Created:	27 Nov 2025

Make:	Nissan	Model:	Bluebird	
Body Style:	Sedan	Year:	2005	
Rego No.:	HMQ923	Rego Expiry:	01 Jul 2026	
WoF Expiry:	02 Jun 2026	Odometer:	152,193 Kms	
Good No.:	27792922	VIN:	7AT0DH1EX14185482	
Next Service: 162194 Service History: No				
Note: This report is r	not a warranty			
his report is a quide only. Consideration is made for age and mileage. Parts have not been dismantled or

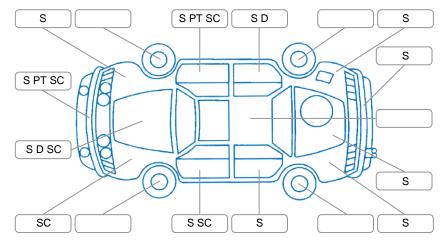
ney				
S = Scratch	R = Rust	C = Crack	* = Decals	W = Significant scuffs
D = Dent	PT = Paint defect	P = Pin dent	SC = Stone Chips

Note: some defects and blemishes may not be displayed in the diagram

Minor stone chips on windscreen
