Report ID:	27,801,083	Version:	1
Created:	25 Nov 2025

Make:	Volkswagen	Model:	Polo
Body Style:	Hatchback	Year:	2007
Rego No.:	JZQ504	Rego Expiry:	25 Feb 2026
WoF Expiry:	26 Nov 2026	Odometer:	104,051 Kms
Good No.:	27801083	VIN:	WVWZZZ9NZ7D025249
Next Service:	114,050km's	Service History:	No

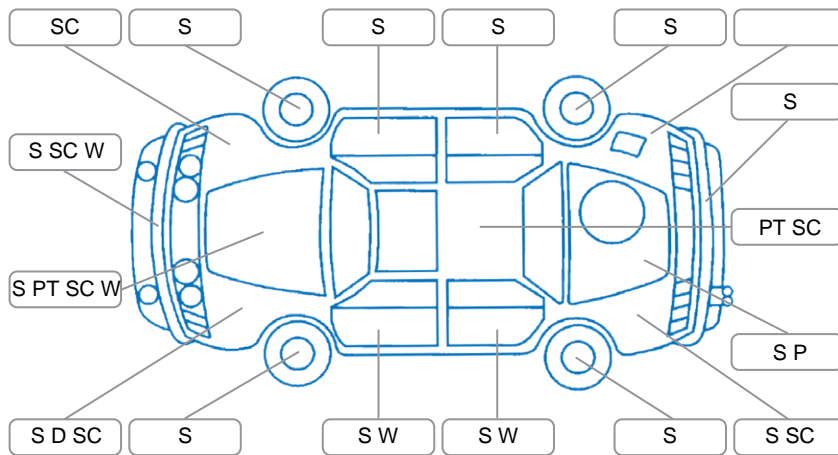
Note: some defects and blemishes may not be displayed in the diagram

Plastic cover missing off front corner of right side roof rail. Plastic cover missing off rear window wiper arm. Indicator repeater lens in left side wing mirror is cracked, broken & wing mirror cover is cracked/broken. Radio aerial stork is missing. Scratches & scuffs on left side sill.
