•	Report ID:	27,802,399	Version:	2
	Created:	29 Nov 2025

Make:	Mazda	Model:	CX-9
Body Style:	suv	Year:	2015
Rego No.:	JGQ978	Rego Expiry:	20 Aug 2026
WoF Expiry:	12 Dec 2026	Odometer:	128,344 Kms
Good No.:	27802399	VIN:	JM0TB10A5F0432470
Next Service:	138000kms	Service History:	Yes

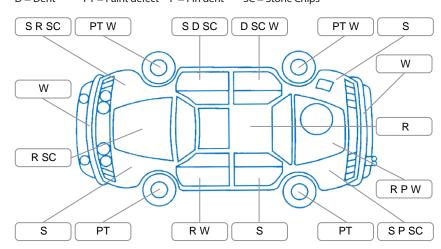
Key * = DecalsW = Significant scuffs S = ScratchR = RustC = CrackD = DentPT = Paint defect P = Pin dentSC = Stone Chips

Note: some defects and blemishes may not be displayed in the diagram $\,$

Spider rust on roof
