Basic Condition Guide

Make:	Mazda	Model:	Axela		
Body Style:	Sedan	Year:	2013		
Rego No.: NPL500		Rego Expiry:	21 Jan 2026		
WoF Expiry: 31 Oct 2026		Odometer:	193,700 Kms		
Good No.: 27813570 VIN: 7AT0C13JX215		7AT0C13JX21599323			
Next Service: Unknown Service History: No					
Note: This report is not a warranty This report is a guide only. Consideration is made for age and mileage. Parts have not been dismantled or diagnostic testing undertaken. The vehicle has been driven up to 50km/h from cold. The Vendor recommends a full mechanical inspection prior to purchase and this can be arranged for an additional charge.

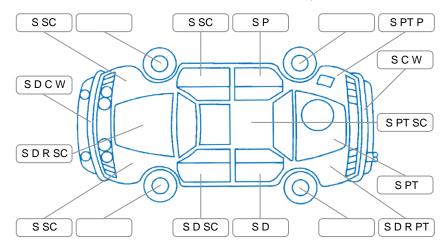
Note: some defects and blemishes may not be displayed in the diagram $\,$

Dent in left sill

Glue residue on bumper and left guard

Large stone chips in windscreen

B pillar trims flaking off
