Basic Condition Guide

•	Report ID:	27,815,203	Version:	1
	Created:	03 Dec 2025

Make:	Hyundai	Model:	Santa FE
Body Style:	suv	Year:	2017
Rego No.:	KKQ4	Rego Expiry:	27 Feb 2026
WoF Expiry:	16 Jul 2026	Odometer:	165,344 Kms
Good No.:	27815203	VIN:	KMHSU81BSHU750679
Next Service:	173,715	Service History:	No

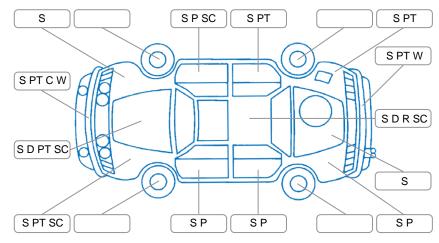
Note: some defects and blemishes may not be displayed in the diagram

Minor stone chips in windscreen

Moisture in left mirror indicator - cracked
