Basic Condition Guide

•	Report ID:	27,816,902	Version:	1
	Created:	28 Nov 2025

Make:	Honda	Model:	FIT
Body Style:	Hatchback	Year:	2003
Rego No.:	EFJ215	Rego Expiry:	30 Dec 2025
WoF Expiry:	15 Nov 2025	Odometer:	157,221 Kms
Good No.:	27816902	VIN:	7A88G2Y0707533588
Next Service:	158,000	Service History:	Yes

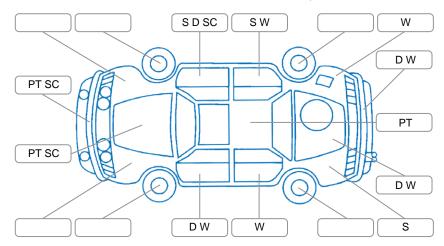
ney				
S = Scratch	R = Rust	C = Crack	* = Decals	W = Significant scuffs
D = Dent	PT = Paint defect	P = Pin dent	SC = Stone Chips

Note: some defects and blemishes may not be displayed in the diagram

Headlights faded. Spare tyre bracket broken. Clear coat faded. Left wing mirror scuffed. Right rear of rear bumper poor fitment.
