| Make: | Honda | Model: | Beat |
| Body Style: | Sports Car | Year: | 1991 |

Body Inspection Comments

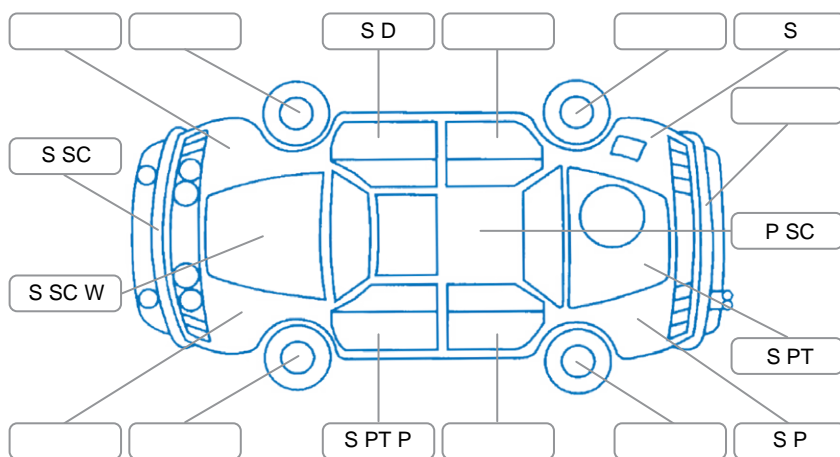
S = Scratch R = Rust C = Crack * = Decals W = Significant scuffs
D = Dent PT = Paint defect P = Pin dent SC = Stone Chips

Note: some defects and blemishes may not be displayed in the diagram

Left rear taillight lens has cracks in it. Centre caps missing off all alloy wheels. Right front guard indicator repeater lens has a crack in it. Spare wheel, space saver tyre side walls are cracking & perishing, needs replaced.
