Basic Condition Guide

Report ID:	27,826,996	Version:	3	
Created:	09 Dec 2025

Ĭ		<u> </u>		
Make:	Toyota	Model:	Surf		
Body Style:	Wagon	Year:	1996		
Rego No.:	EEJ293	Rego Expiry:	27 May 2026		
WoF Expiry:	11 Apr 2026	Odometer:	286,389 Kms		
Good No.:	27826996	VIN:	7A8H60G0707017828		
Next Service:	296, 393 Kms	Service History:	No		
Note: This report is not a warranty

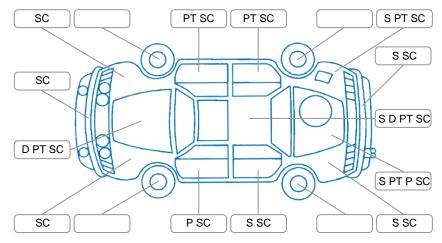
Note: some defects and blemishes may not be displayed in the diagram

Plastic bull bar cover cracked.

LF guard mirror missing.

Minor crack in windscreen.

LH taillight cracked.
