# **Basic Condition Guide**

•	Report ID:	27,828,279	Version:	1
	Created:	03 Dec 2025

Make:	Toyota	Model:	Hiace
Body Style:	Van	Year:	2009
Rego No.:	KZM235	Rego Expiry:	26 Sep 2026
WoF Expiry:	03 Sep 2026	Odometer:	349,629 Kms
Good No.:	27828279	VIN:	7AT0H60FX17045832
Next Service:	355,471kms	Service History:	No

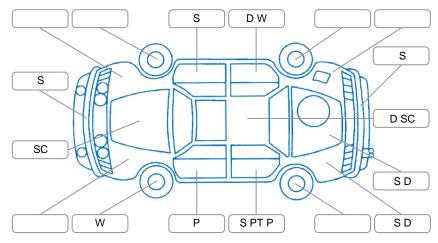
S = Scratch R = Rust C = Crack \*= Decals W = Significant scuffs D = Dent PT = Paint defect P = Pin dent SC = Stone Chips

Note: some defects and blemishes may not be displayed in the diagram

Water in right head light. Both head lights have minor cracks. Rear badge is missing. Rear mirror on tail gate is missing.
