| Report ID: | 27,828,365 | Version: | 1 |

| Make: | Toyota | Model: | Corolla |
| Body Style: | Wagon | Year: | 2006 |

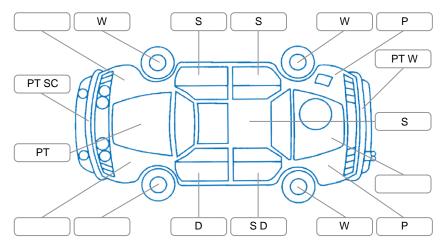
W = Significant scuffs S = ScratchR = RustC = Crack* = DecalsD = DentPT = Paint defect P = Pin dentSC = Stone Chips

Note: some defects and blemishes may not be displayed in the diagram $\,$

Body Inspection Comments

Side skirts loose
