Basic Condition Guide

-	Report ID:	27,829,465	Version:	1
	Created:	04 Dec 2025

Make:	Ford	Model:	Territory
Body Style:	SUV	Year:	2006
Rego No.:	DHE363	Rego Expiry:	29 Jan 2026
WoF Expiry:	13 Feb 2026	Odometer:	271,548 Kms
Good No.:	27829465	VIN:	6FPAAAJGAT6T76683
Next Service:	no record	Service History:	No
Note: This report is	not a warranty	,	<u> </u>
diagnostic testing un		een driven up to 50km/ł	arts have not been dismantled or n from cold. The Vendor recommends a

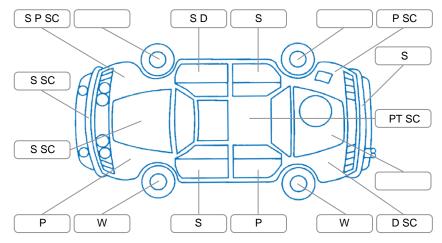
W = Significant scuffs S = ScratchR = RustC = Crack* = Decals D = DentPT = Paint defect P = Pin dentSC = Stone Chips

Note: some defects and blemishes may not be displayed in the diagram

Body Inspection Comments

Left door mirror housing is broken. Edge of right tail light is cracked. Minor wiper scratch in right side of windshield. Paint is fading on roof.Right front guard indicator is cracked. Left front wheel centre cap is cracked. Left rear wheel centre cap is missing.
