•	Report ID:	27,831,767	Version:	1
	Created:	04 Dec 2025

Make:	BMW	Model:	1201
Body Style:	Hatchback	Year:	2009
Rego No.:	NJN242	Rego Expiry:	15 Mar 2026
WoF Expiry:	20 Aug 2026	Odometer:	88,881 Kms
Good No.:	27831767	VIN:	WBAUD32060P220834
Next Service:	98000	Service History:	No

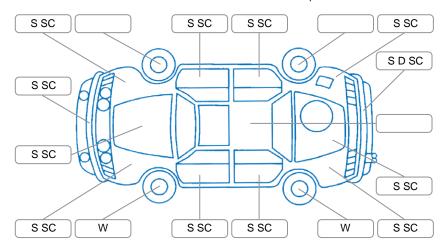
Key				
S = Scratch	R = Rust	C = Crack	* = Decals	W = Significant scuffs
D = Dent	PT = Paint defect	P = Pin dent	SC = Stone Chips

Note: some defects and blemishes may not be displayed in the diagram  $\,$

No flat tyre kit
