# **Basic Condition Guide**

•	Report ID:	27,841,724	Version:	4
	Created:	12 Dec 2025

Make:	Suzuki	Model:	Swift
Body Style:	Hatchback	Year:	2022
Rego No.:	PBE728	Rego Expiry:	15 Feb 2026
WoF Expiry:	19 Mar 2026	Odometer:	54,525 Kms
Good No.:	27841724	VIN:	JSAAZC83S00406061
Next Service:	59,000km	Service History:	Yes

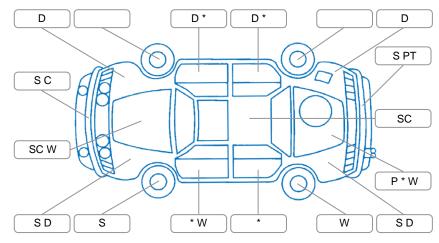
itey				
S = Scratch	R = Rust	C = Crack	* = Decals	W = Significant scuffs
D = Dent	PT = Paint defect	P = Pin dent	SC = Stone Chips

Note: some defects and blemishes may not be displayed in the diagram

Grab handles in car, need refit. RR seat belt refit. Parcel tray missing.R bumper Left reflector missing. Grille centre black trim cracked. R bumper refit. F bumper crack. LF tyre sidewall damage. RF seat belt beginning to fray.
