Basic Condition Guide

•	Report ID:	27,842,372	Version:	1
	Created:	12 Dec 2025

Make:	Nissan	Model:	X-Trail
Body Style:	Wagon	Year:	2010
Rego No.:	MDS865	Rego Expiry:	13 Apr 2026
WoF Expiry:	27 Dec 2025	Odometer:	220,400 Kms
Good No.:	27842372	VIN:	7AT0DH6LX19100182
Next Service:	228,000kms	Service History:	No

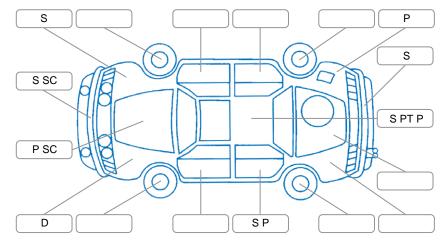
ney				
S = Scratch	R = Rust	C = Crack	* = Decals	W = Significant scuffs
D = Dent	PT = Paint defect	P = Pin dent	SC = Stone Chips

Note: some defects and blemishes may not be displayed in the diagram

Minor hail damage and paint fading on roof. Right rear monsoon visor is missing.
