Basic Condition Guide

Make:	Mercedes-Benz	Model:	E280
Body Style:	Sedan	Year:	2000
Rego No.:	FWZ583	Rego Expiry:	16 Dec 2025
WoF Expiry:	04 Nov 2026	Odometer:	198,423 Kms
Good No.: 27846225		VIN:	WDB2100632B106607
Next Service:	206,000kms	Service History:	No

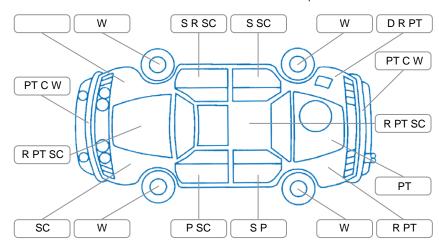
* = DecalsW = Significant scuffs S = ScratchR = RustC = CrackD = DentPT = Paint defect P = Pin dentSC = Stone Chips

Note: some defects and blemishes may not be displayed in the diagram

Reflector and rear fog light on toot are cracked. Right front door scuff plate is not fitted.
