Report ID: 27,850,4		27,850,400	Version:	3
	Created:	10 Dec 2025

Make:	Subaru	Model:	Legacy
Body Style:	Sedan	Year:	2007
Rego No.:	LYF514	Rego Expiry:	22 Oct 2026
WoF Expiry:	23 Oct 2026	Odometer:	205,429 Kms
Good No.:	27850400	VIN:	7AT0GF0BX18078425
Next Service:	207,652kms	Service History:	No

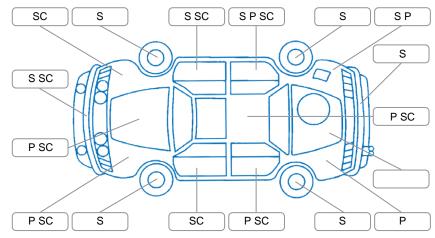
rey				
S = Scratch	R = Rust	C = Crack	* = Decals	W = Significant scuffs
D = Dent	PT = Paint defect	P = Pin dent	SC = Stone Chips

Note: some defects and blemishes may not be displayed in the diagram

Bonnet edges bent.

Chipped windscreen.

Left wing mirror casing & indicator lens broken.
