•	Report ID:	27,856,199	Version:	2
	Created:	12 Dec 2025

Make:	Ford	Model:	Transit
Body Style:	Van	Year:	2000
Rego No.:	NPP799	Rego Expiry:	05 Jul 2026
WoF Expiry:	28 Nov 2026	Odometer:	334,118 Kms
Good No.:	27856199	VIN:	WF0LXXGBFLYC36014
Next Service:	337,682kms	Service History:	No

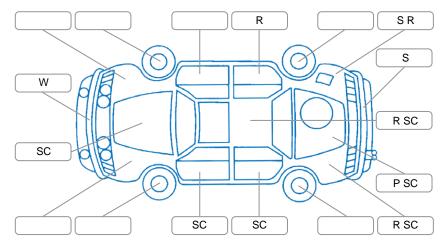
W = Significant scuffs S = ScratchR = RustC = Crack* = DecalsD = DentPT = Paint defect P = Pin dentSC = Stone Chips

Note: some defects and blemishes may not be displayed in the diagram

Headlight lenses dull.

Rust in rear door shut, front door steps, right A pillar r/f wheel arch.

Rusty areas around vehicle, further inspection suggested.
