| Make: | Holden | Model: | Barina |
| Body Style: | Hatchback | Year: | 2010 |

Body Inspection Comments

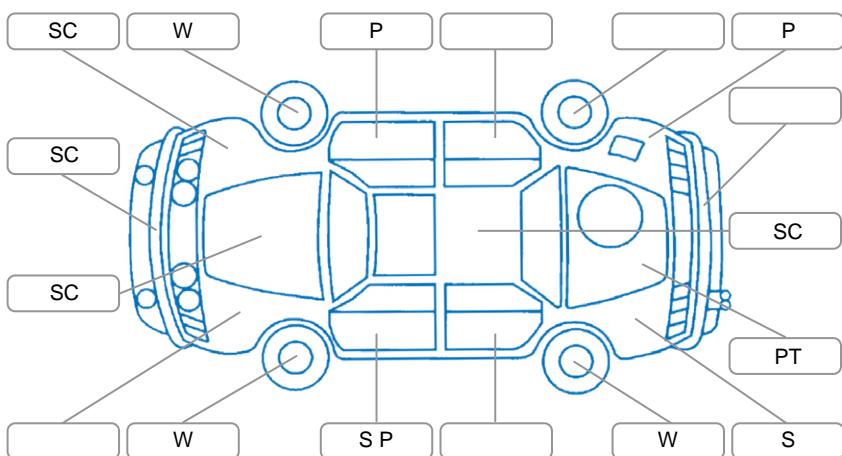
S = Scratch R = Rust C = Crack * = Decals W = Significant scuffs
 D = Dent PT = Paint defect P = Pin dent SC = Stone Chips

Note: some defects and blemishes may not be displayed in the diagram

Minor stone crack in left side of windshield. Paint of door handles are flaking. Left rear tyre needs replacement. Left rear wheel centre cap is missing.
