| Make: | Mazda | Model: | MPV |
| Body Style: | Wagon | Year: | 2006 |

Body Inspection Comments

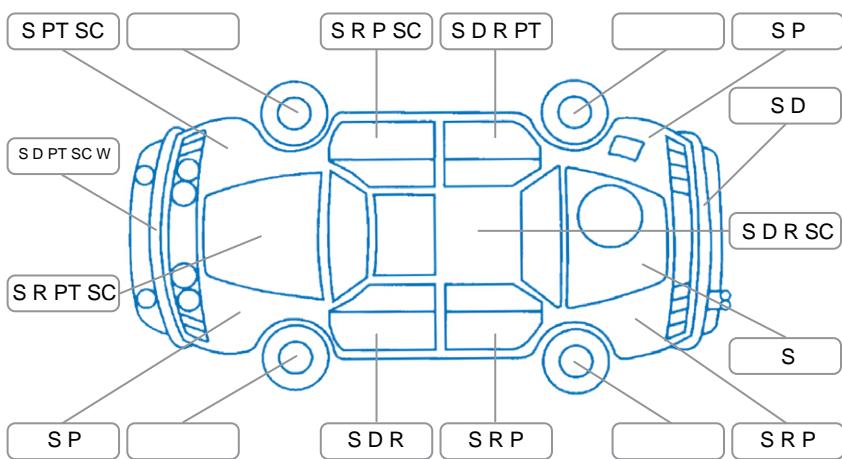
S = Scratch R = Rust C = Crack * = Decals W = Significant scuffs
 D = Dent PT = Paint defect P = Pin dent SC = Stone Chips

Note: some defects and blemishes may not be displayed in the diagram
