Basic Condition Guide

•	Report ID: 27,865,029		Version: 2	
	Created:	30 Dec 2025

Make:	Suzuki	Model:	Baleno
Body Style:	Hatchback	Year:	2017
Rego No.:	KHT589	Rego Expiry:	13 Feb 2026
WoF Expiry:	26 Feb 2026	Odometer:	124,446 Kms
Good No.:	27865029	VIN:	MA3EWB52S00272592
Next Service:	131,703	Service History:	No

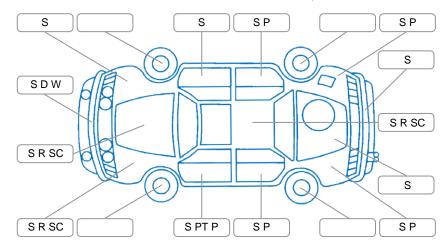
W = Significant scuffs S = ScratchR = RustC = Crack* = DecalsD = DentPT = Paint defect P = Pin dentSC = Stone Chips

Note: some defects and blemishes may not be displayed in the diagram

Headlights yellowing. Stone chips in windscreen. Paint worn in drivers door sill
