| Report ID: | 27,874,822 | Version: | 3 |

| Make: | Mitsubishi | Model: | Triton |
| Body Style: | Utility | Year: | 2019 |

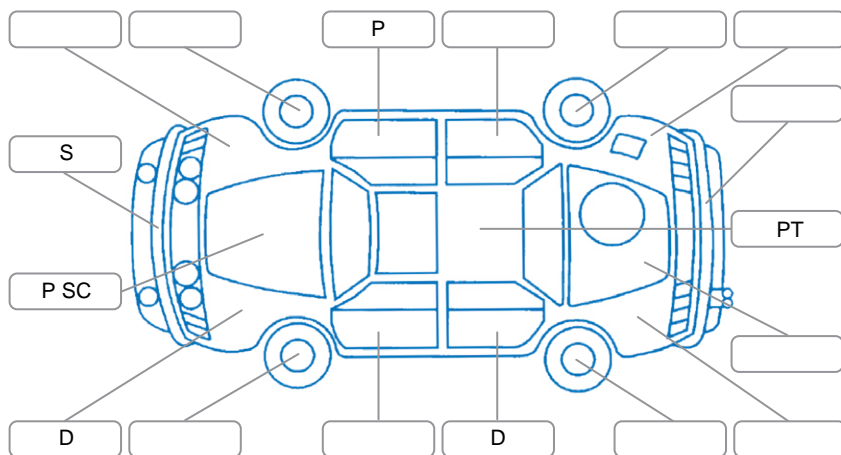
S = Scratch R = Rust C = Crack * = Decals W = Significant scuffs
D = Dent PT = Paint defect P = Pin dent SC = Stone Chips

Body Inspection Comments

Headliner stains. Right sill dent.
