Basic Condition Guide

| KIA | Model: | Sportage |
| SUV | Year: | 2014 |
| HNL805 | Rego Expiry: | 17 Jul 2026 |

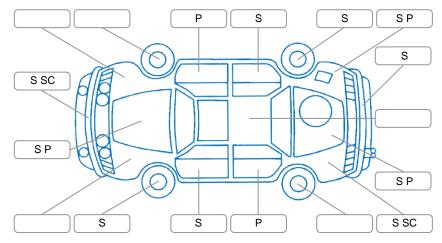
S = Scratch* = DecalsW = Significant scuffs R = RustC = CrackD = DentPT = Paint defect P = Pin dentSC = Stone Chips

Note: some defects and blemishes may not be displayed in the diagram $\,$

Stone chip near CVA on windscreen.
