Basic Condition Guide

•	Report ID:	27,886,905	Version:	1
	Created:	29 Dec 2025

Make:	Volkswagen	Model:	Golf
Body Style:	Wagon	Year:	2008
Rego No.:	KEM649	Rego Expiry:	06 Feb 2026
WoF Expiry:	22 Dec 2026	Odometer:	204,219 Kms
Good No.:	27886905	VIN:	WVWZZZ1KZ8M356433
Next Service:	213000	Service History:	No

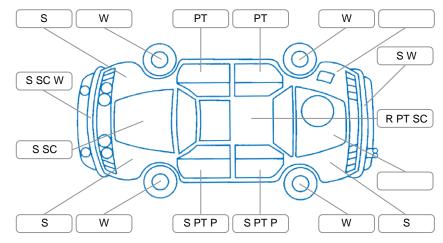
itey				
S = Scratch	R = Rust	C = Crack	* = Decals	W = Significant scuffs
D = Dent	PT = Paint defect	P = Pin dent	SC = Stone Chips

Note: some defects and blemishes may not be displayed in the diagram

Left Sill Dent, Door Trim Sagging.
