Make:	Volkswagen	Model:	T5
Body Style:	Van	Year:	2007
Rego No.:	EFU963	Rego Expiry:	16 Oct 2026
WoF Expiry:	05 Nov 2026	Odometer:	371,442 Kms
Good No.:	27914873	VIN:	WV2ZZZ7HZ8H012925
Next Service:	362,400kms	Service History:	No

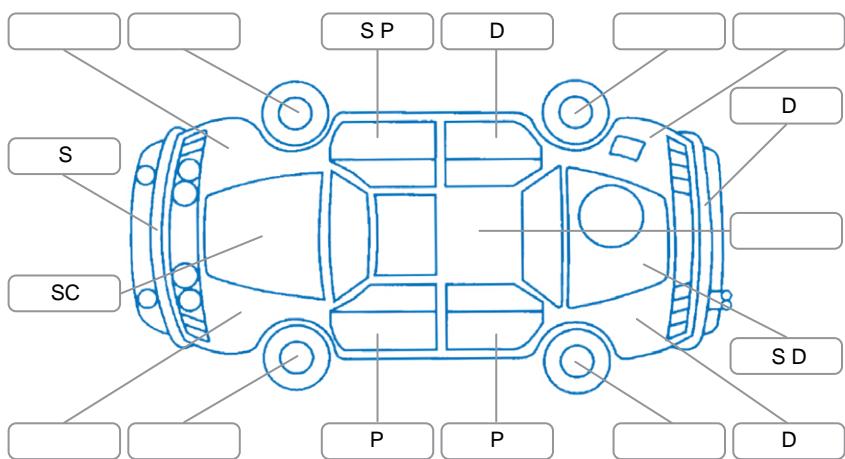
Note: some defects and blemishes may not be displayed in the diagram

Right door check strap is broken. Left headlight service hole cover is missing (Dust and insects inside). Front bumper left blank cover is missing.  
Minor stone cracks in windshield.
