| Make: | Suzuki | Model: | Swift |
| Body Style: | Hatchback | Year: | 2005 |

Body Inspection Comments

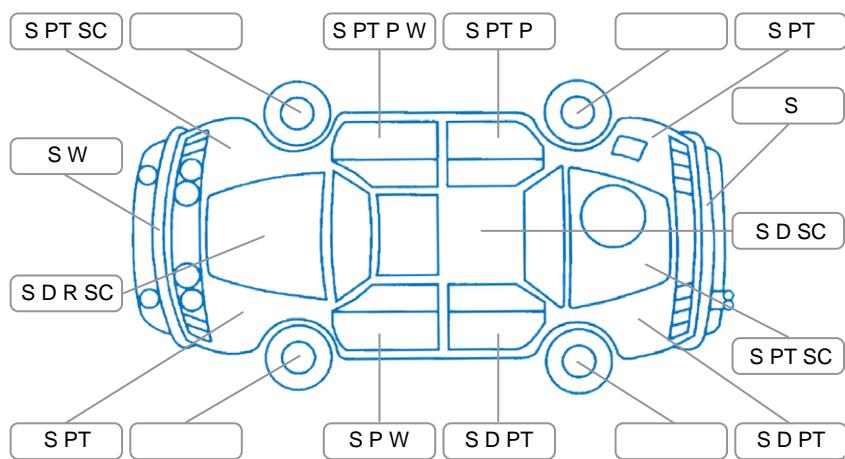
S = Scratch R = Rust C = Crack * = Decals W = Significant scuffs
 D = Dent PT = Paint defect P = Pin dent SC = Stone Chips

Note: some defects and blemishes may not be displayed in the diagram
