| Make: | Honda | Model: | Edix |
| Body Style: | Hatchback | Year: | 2005 |
| Rego No.: | KDA771 | Rego Expiry: | 09 Oct 2026 |

Body Inspection Comments

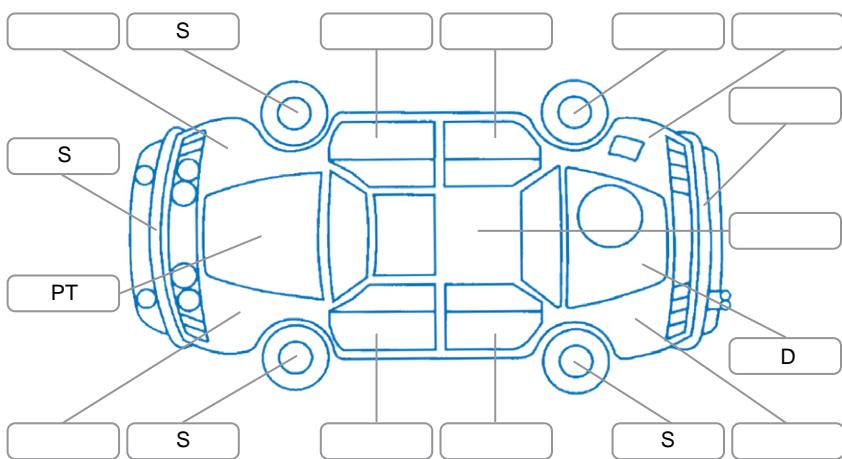
S = Scratch R = Rust C = Crack * = Decals W = Significant scuffs
 D = Dent PT = Paint defect P = Pin dent SC = Stone Chips

Note: some defects and blemishes may not be displayed in the diagram

RF fog light broken.
 Drivers door seal is torn.
