| Report ID: | 27,947,795 | Version: | 2 |

| Make: | Mazda | Model: | Atenza |
| Body Style: | Wagon | Year: | 2008 |

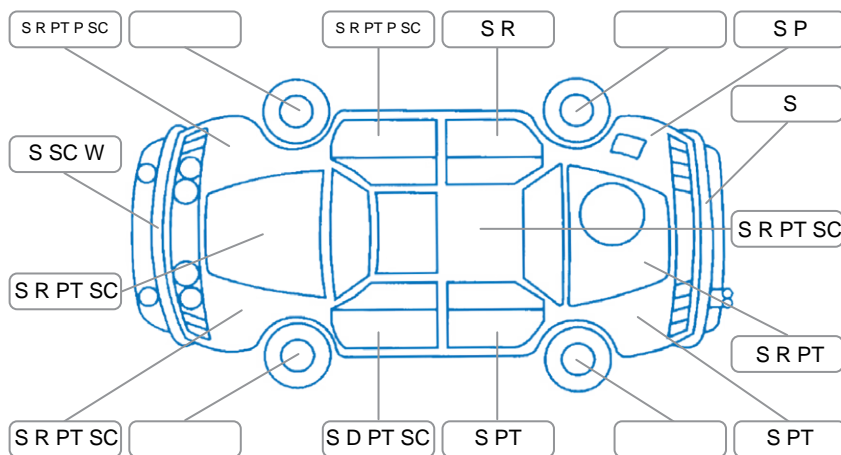
S = Scratch R = Rust C = Crack \* = Decals W = Significant scuffs  
D = Dent PT = Paint defect P = Pin dent SC = Stone Chips

Note: some defects and blemishes may not be displayed in the diagram

Stone Chips Windscreen
