| Report ID: | 27,958,582 | Version: | 2 |

| Make: | Mitsubishi | Model: | 380 |
| Body Style: | Sedan | Year: | 2008 |

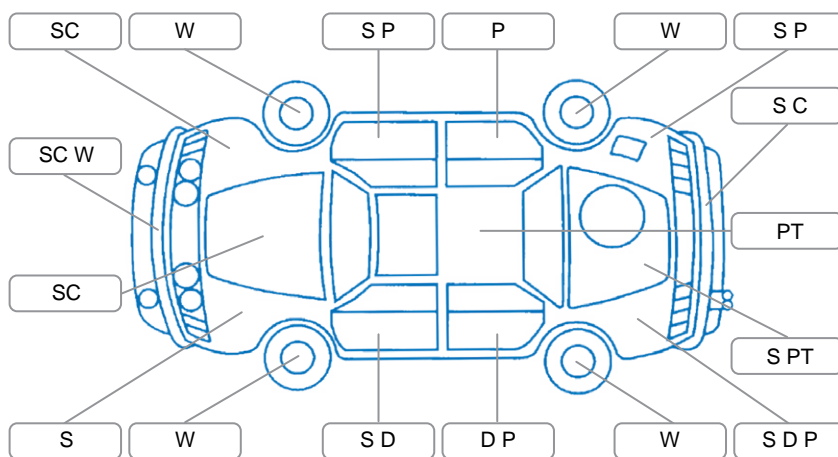
Note: some defects and blemishes may not be displayed in the diagram

Body Inspection Comments

Front right park light isn't working
