| Report ID: | 27,969,695 | Version: | 1 |

| Make: | Honda | Model: | Elyson |
| Body Style: | Wagon | Year: | 2006 |

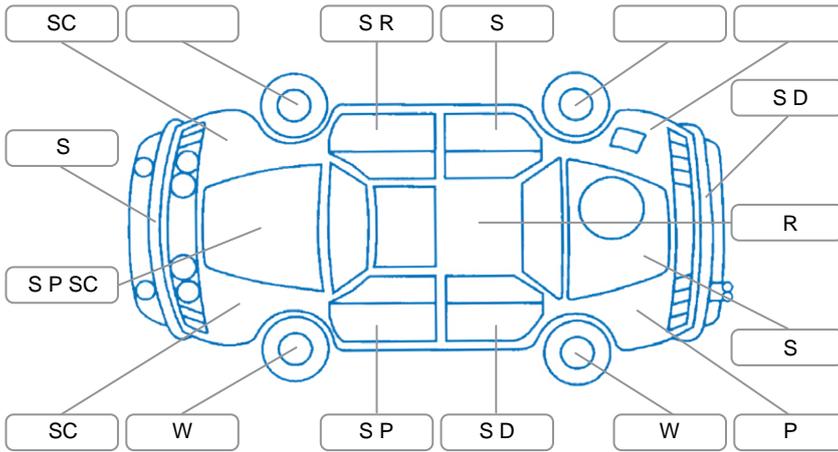
Key
 S = Scratch R = Rust C = Crack * = Decals W = Significant scuffs
 D = Dent PT = Paint defect P = Pin dent SC = Stone Chips

Note: some defects and blemishes may not be displayed in the diagram

- Rear view mirror driver side close control not responding for FR mirror
- FR door interior seal torn
- Headlights faded
- FL door hinge creaking
