Make:	Ford	Model:	Ranger
Body Style:	Utility	Year:	2013
Rego No.:	JYY150	Rego Expiry:	02 Mar 2026
WoF Expiry:	09 Jul 2026	Odometer:	137,500 Kms
Good No.:	27972500	VIN:	MNAUMFF50DW203511
Next Service:	151000 kms	Service History:	No

**Note: This report is not a warranty**

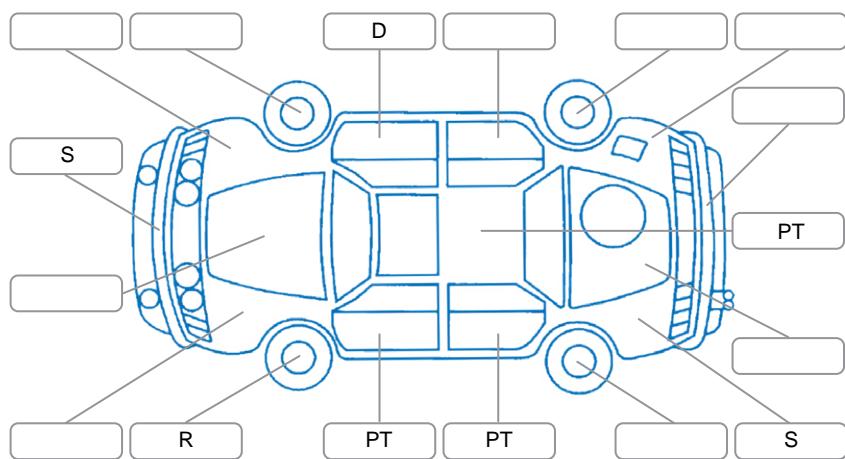
S = Scratch    R = Rust    C = Crack    \* = Decals    W = Significant scuffs  
 D = Dent    PT = Paint defect    P = Pin dent    SC = Stone Chips

Note: some defects and blemishes may not be displayed in the diagram

Front interior dome light trim cracked. Headliner stains. Front seat plastics cracked. Front door check strap clicks. Tray hard lid right latch not latching. Front bumper grille loose. Headlights fading. Front tyres scalloped.
