Report ID:	28,007,449	Version:	3
Created:	24 Apr 2026

Make:	Hyundai	Model:	I30
Body Style:	Hatchback	Year:	2011
Rego No.:	GAR304	Rego Expiry:	05 Oct 2025
WoF Expiry:	24 Apr 2027	Odometer:	158,120 Kms
Good No.:	28007449	VIN:	KMHDB51DMBU357930
Next Service:	150,000	Service History:	No

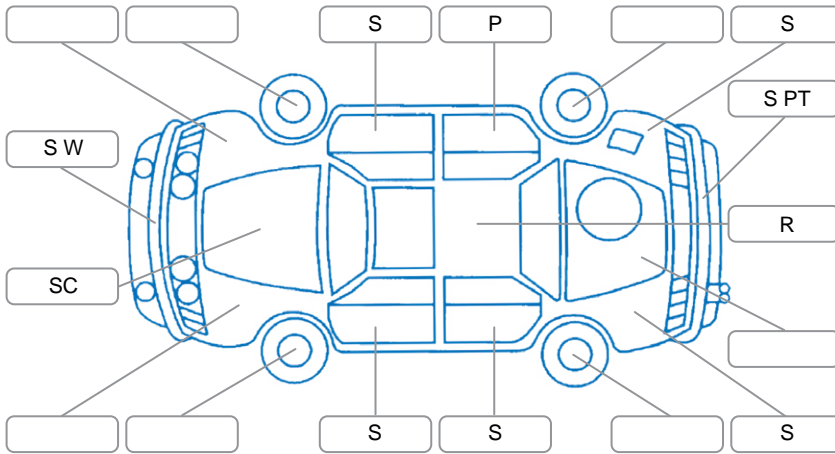
Key
 S = Scratch R = Rust C = Crack * = Decals W = Significant scuffs
 D = Dent PT = Paint defect P = Pin dent SC = Stone Chips

Note: some defects and blemishes may not be displayed in the diagram
