Report ID:	28,019,320	Version:	1
Created:	06 Mar 2026

Make:	Mitsubishi	Model:	L300
Body Style:	Van	Year:	2014
Rego No.:	HRJ854	Rego Expiry:	18 Dec 2026
WoF Expiry:	17 Dec 2026	Odometer:	174,997 Kms
Good No.:	28019320	VIN:	JMAHNP14VDA801049
Next Service:	184,000kms	Service History:	No

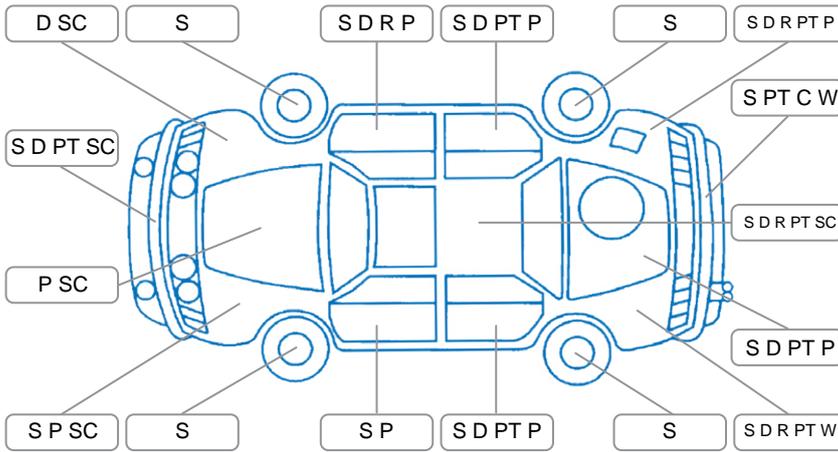
Key
 S = Scratch R = Rust C = Crack * = Decals W = Significant scuffs
 D = Dent PT = Paint defect P = Pin dent SC = Stone Chips

Note: some defects and blemishes may not be displayed in the diagram

Poor panel & paint repair to left side rear door, left rear van side body panel, rear tailgate, right rear van side body panel & right side rear door. Water inside right front indicator lens. Outside edge worn down to cords on left front tyre, needs replaced.
