Report ID:	28,087,963	Version:	2
Created:	04 May 2026

Make:	Mazda	Model:	Atenza
Body Style:	Sedan	Year:	2014
Rego No.:	QJT213	Rego Expiry:	15 Sep 2025
WoF Expiry:	28 Aug 2026	Odometer:	176,141 Kms
Good No.:	28087963	VIN:	7AT0C139X23101953
Next Service:		Service History:	No

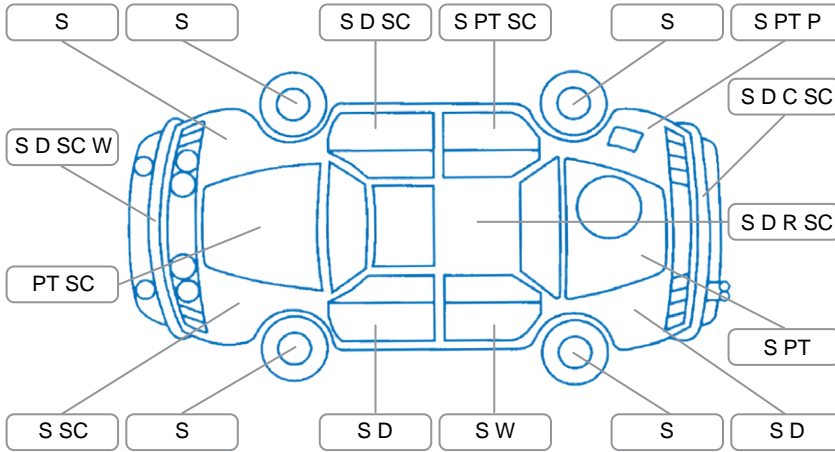
Note: some defects and blemishes may not be displayed in the diagram

Left headlight is damaged, stone chips & scratches in the windscreen, pin dents in both cant rails, left side skirt cracked, both rear tow eye covers missing, right rear reflector damaged, rear bumper needs alignment,
