Report ID:	28,146,532	Version:	1
Created:	28 Apr 2026

Make:	Holden	Model:	Cruze
Body Style:	Wagon	Year:	2013
Rego No.:	GQU104	Rego Expiry:	26 Aug 2026
WoF Expiry:	20 May 2026	Odometer:	102,057 Kms
Good No.:	28146532	VIN:	KL3JA3559DK062266
Next Service:	110000	Service History:	No

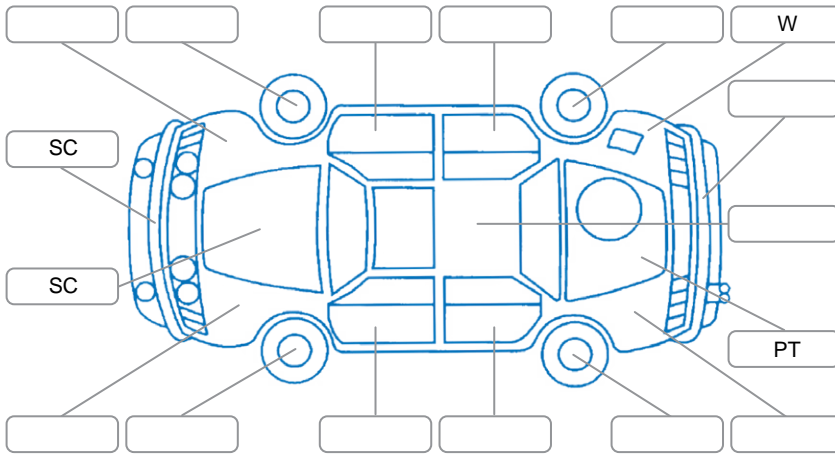
Key
 S = Scratch R = Rust C = Crack * = Decals W = Significant scuffs
 D = Dent PT = Paint defect P = Pin dent SC = Stone Chips

Note: some defects and blemishes may not be displayed in the diagram
