| Report ID: | 28,153,750 | Version: | 2 |

| Make: | Mazda | Model: | CX-5 |
| Body Style: | Wagon | Year: | 2015 |

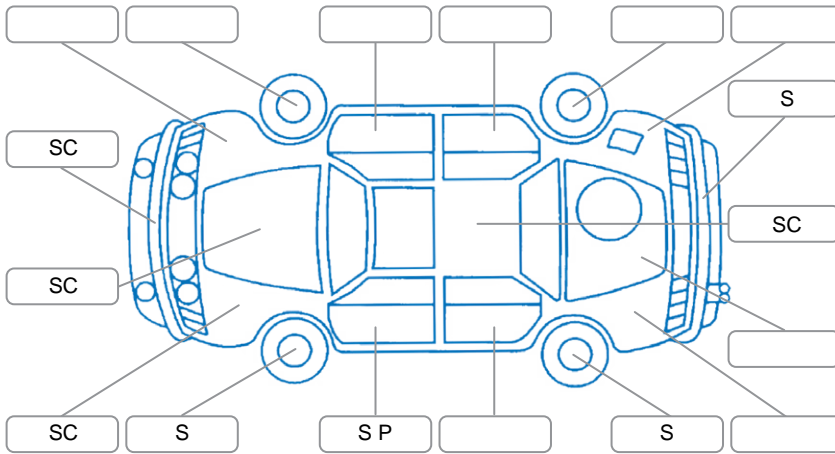
Note: some defects and blemishes may not be displayed in the diagram

Body Inspection Comments

Moisture in left & right inner taillights.
 Rusty stone chips on the roof.
