Report ID:	28,182,517	Version:	1
Created:	18 May 2026

Make:	Nissan	Model:	Navara
Body Style:	Utility	Year:	2009
Rego No.:	FCD786	Rego Expiry:	08 Sep 2026
WoF Expiry:	07 Jan 2027	Odometer:	336,064 Kms
Good No.:	28182517	VIN:	MNTCPUD22A0001039
Next Service:		Service History:	No

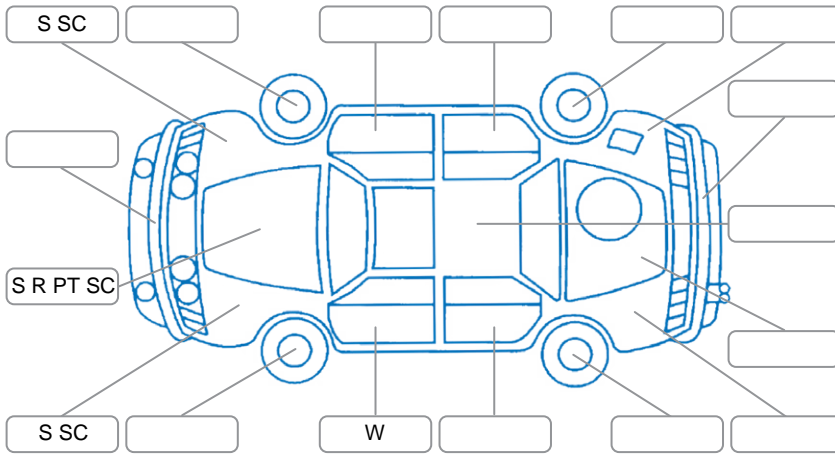
Note: some defects and blemishes may not be displayed in the diagram

Driver door hinges worn out. All tires are scalloped.
 Paintwork faded, clear coat coming off.
 Stone chips, dents, scratches, scuffs all over
