Report ID:	28,183,235	Version:	2
Created:	15 May 2026

Make:	Mercedes-Benz	Model:	GL
Body Style:	Wagon	Year:	2007
Rego No.:	NHU393	Rego Expiry:	22 Jun 2026
WoF Expiry:	16 Sep 2026	Odometer:	122,620 Kms
Good No.:	28183235	VIN:	WDC1648222A299233
Next Service:	116573	Service History:	Yes

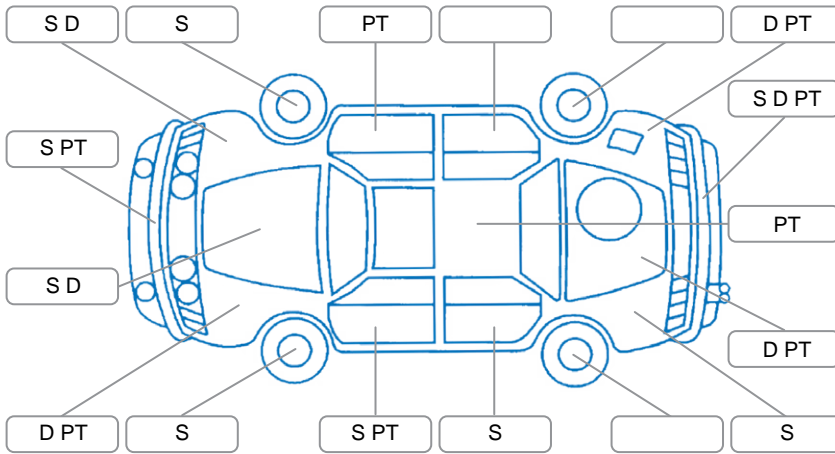
Note: some defects and blemishes may not be displayed in the diagram

R running board crack, center console rear air vent damaged, RR folding seat switch missing, LR window not working, LR door moulding unsecure, bonnet strut weak and need to refit, interior boot rusty, engine oil leak, both headlights faded ,
