Report ID:	28,196,653	Version:	1
Created:	25 May 2026

Make:	Honda	Model:	FIT
Body Style:	Hatchback	Year:	2003
Rego No.:	FUP315	Rego Expiry:	14 Nov 2026
WoF Expiry:	18 Jun 2026	Odometer:	135,417 Kms
Good No.:	28196653	VIN:	7AT08G2YX11752798
Next Service:	142,000kms	Service History:	No

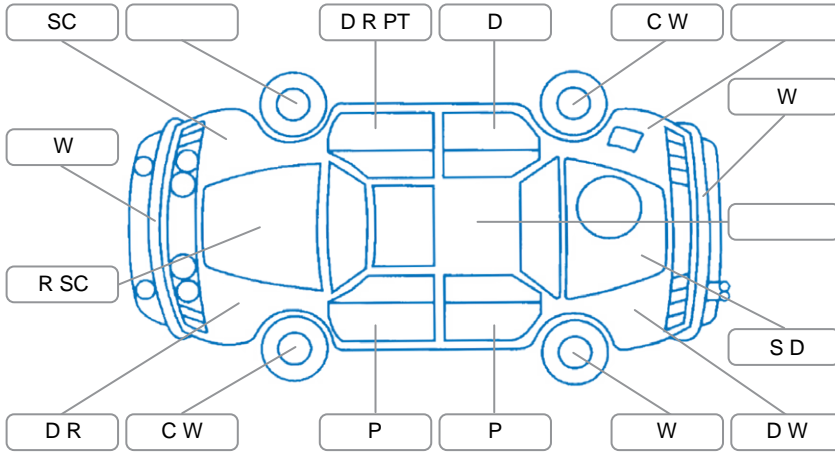
Paint is cracked in rear bumper. Paint is flaking around dent at bottom of driver's door and surface rust is developing. Minor stone cracks in left side of windshield. Floor panel of cargo (space for spare tyre) is rusty.
