| Report ID: | 28,226,607 | Version: | 1 |

| Make: | Mitsubishi | Model: | Pajero Sport |
| Body Style: | SUV | Year: | 2022 |

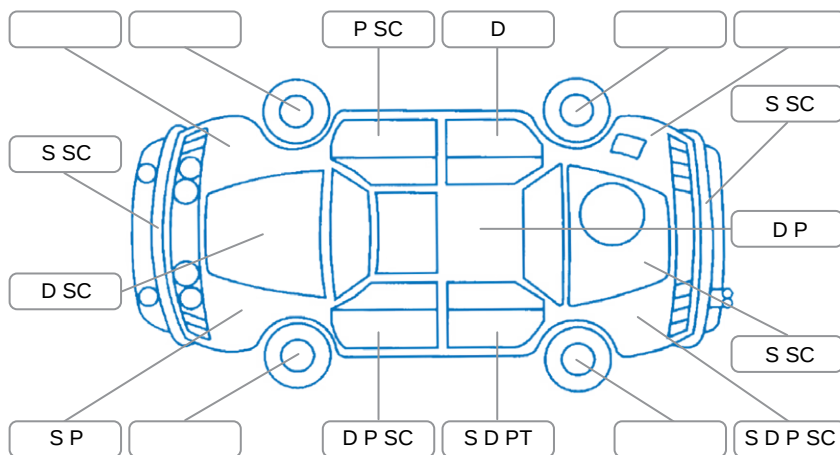
Note: some defects and blemishes may not be displayed in the diagram

RH front bumper moulding fits poorly. LH running board damaged.  
RF, LF, and tailgate door seals torn.  
Spare wheel missing.  
LR inner wheel arch damaged.
