Report ID:	28,261,474	Version:	1
Created:	25 Jun 2026

Make:	Volkswagen	Model:	Tiguan
Body Style:	SUV	Year:	2016
Rego No.:	JMF204	Rego Expiry:	15 Oct 2026
WoF Expiry:	10 Dec 2026	Odometer:	129,698 Kms
Good No.:	28261474	VIN:	WVGZZZ5NZFW085751
Next Service:	130,861kms	Service History:	No

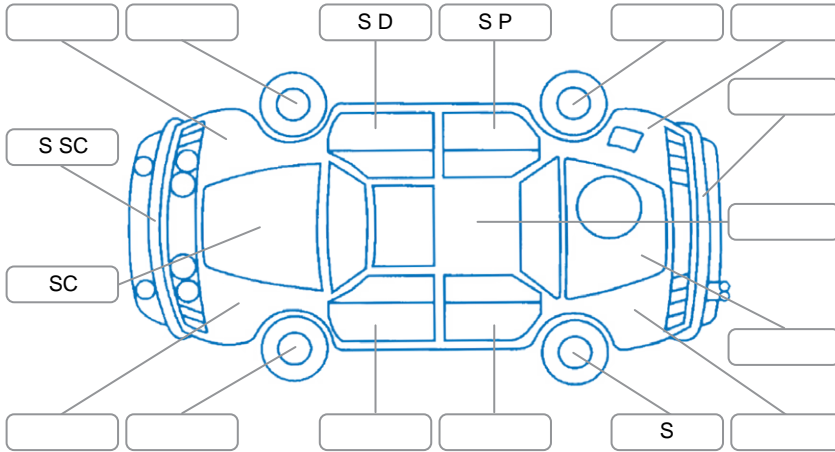
Key
 S = Scratch R = Rust C = Crack * = Decals W = Significant scuffs
 D = Dent PT = Paint defect P = Pin dent SC = Stone Chips

Note: some defects and blemishes may not be displayed in the diagram
