| Report ID: | 28,267,824 | Version: | 2 |

| Make: | Mazda | Model: | Bt-50 |
| Body Style: | Utility | Year: | 2009 |

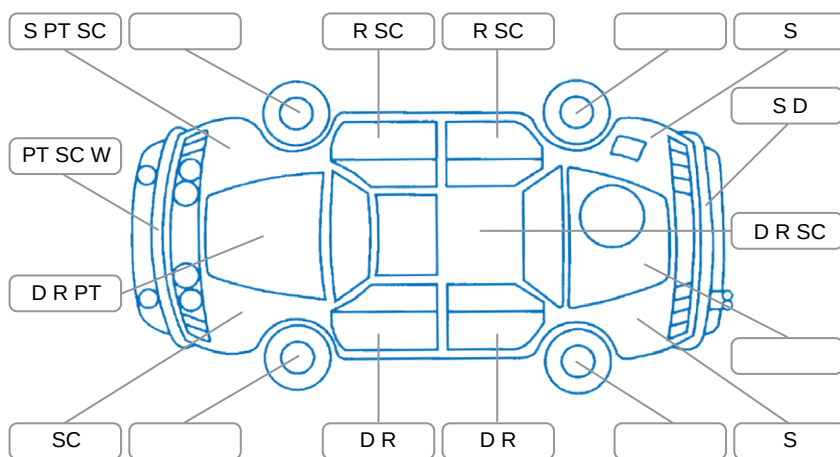
Note: some defects and blemishes may not be displayed in the diagram

Bonnet moulding is missing. Paint is flaking and developing surface rust on bonnet (Under bonnet is rusty) . Radiator support is rusty. Spare tyre and tools are missing. Left running board has bent and missing rear end covers. Clear paint is flaking on right rear door.
