| Make: | Nissan | Model: | Navara |
| Body Style: | Utility | Year: | 2024 |
| Good No.: | 28415812 | VIN: | MNTCBND23A0031792 |

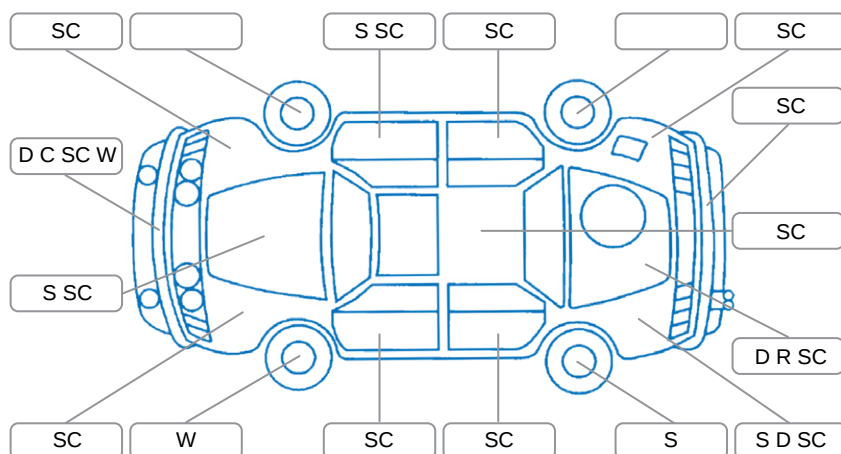
S = Scratch    R = Rust    C = Crack    \* = Decals    W = Significant scuffs  
D = Dent    PT = Paint defect    P = Pin dent    SC = Stone Chips

Note: some defects and blemishes may not be displayed in the diagram

Front bumper left side damaged big dent and cracked/broken  
Missing tow bar tongue  
No key for hard lid
