| Report ID: | 28,419,293 | Version: | 1 |

| Make: | Nissan | Model: | NV200 |
| Body Style: | Van | Year: | 2010 |

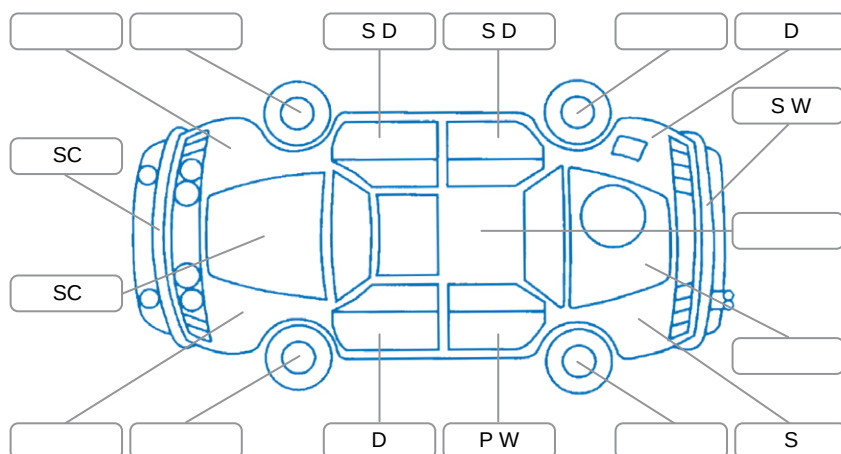
Note: some defects and blemishes may not be displayed in the diagram

Front tyres wearing on outer edges  
Moisture in front right guard indicator  
Stone chip far left side of front windscreen
